# John Deere 410R Sprayer Preservation Dossier

Documented preservation and coating installation record for a John Deere 410R self-propelled sprayer, with condition notes, surface preparation, component coverage, chemical exposure areas, coating placement, and future inspection reference points.

John Deere 410R self-propelled sprayer

Preservation and coating installation dossier

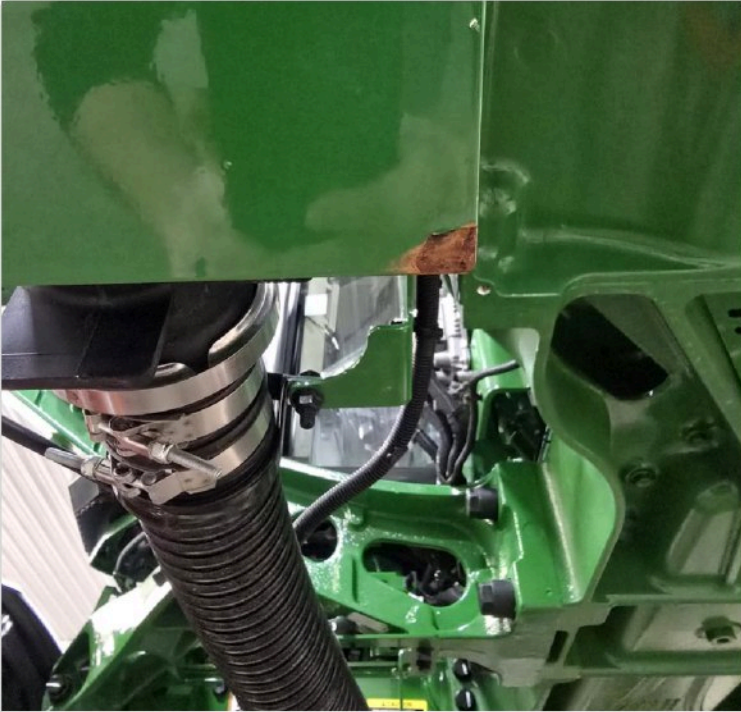
**INTAKE CONDITION AREA****INTAKE CONDITION EVIDENCE**

The documented paint chip and rust on the lower front passenger-side mirror housing are preserved as condition evidence.

- Visible condition notes include the lower front passenger-side mirror housing paint chip with rust, and minor bubbling/repaint evidence on outer wheel faces.
- The available photo set supports a component-rich record rather than a same-angle cosmetic transformation set. The public dossier therefore separates intake condition evidence from completed service-zone documentation.

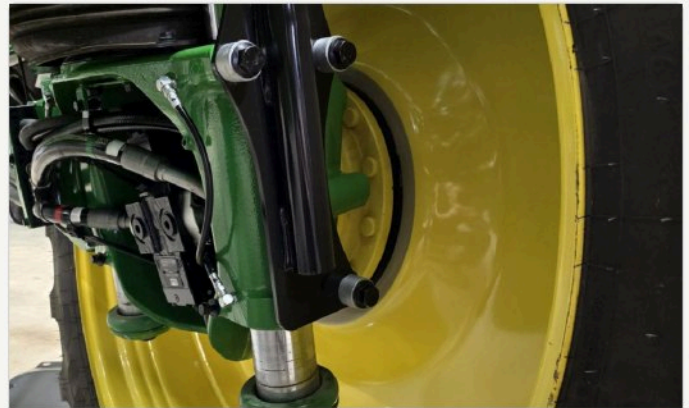
**WHEEL-FACE REFERENCE****CERAKOTE MC-2200 ON DOCUMENTED WHEEL SURFACES**

Outer wheel faces were noted as having minor bubbling and bead-edge repaint evidence at intake.

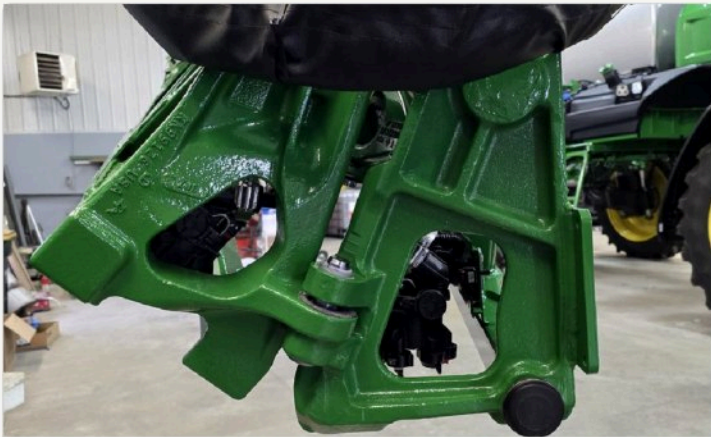
#### ACCESS PROOF FOR DOCUMENTED COVER REMOVAL AND COATING WORK

Removed cover evidence supports access-oriented service documentation.

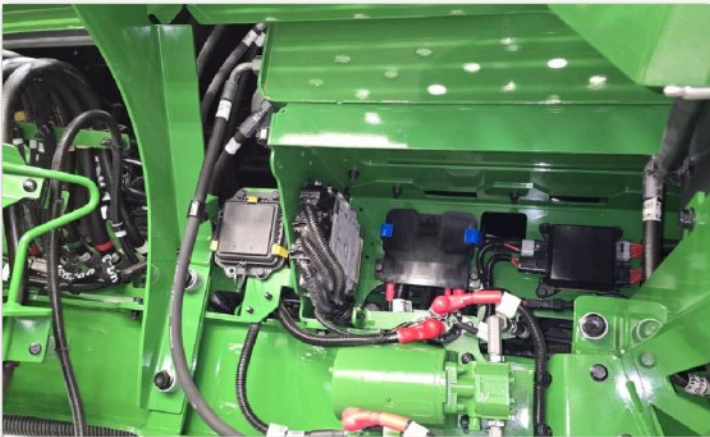
#### CERAKOTE MC-2200 ON DOCUMENTED FRAME AND UNDER-PLATFORM SURFACES

Under-platform routing and frame geometry show the inspection value of close equipment documentation.

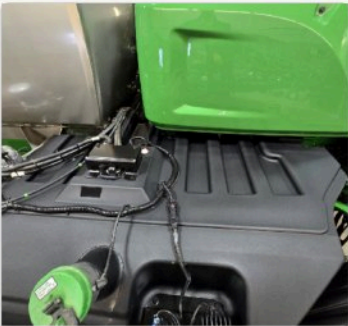
**BLACK PLASTIC TANK AREA**

**ROAR LEGACY ON DOCUMENTED BLACK PLASTIC SURFACES**

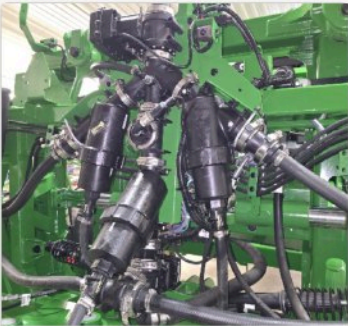
**FITTINGS AND COUPLERS**

**CERAKOTE MC-2200 ON DOCUMENTED FITTINGS, COUPLERS, AND MANIFOLD AREAS**

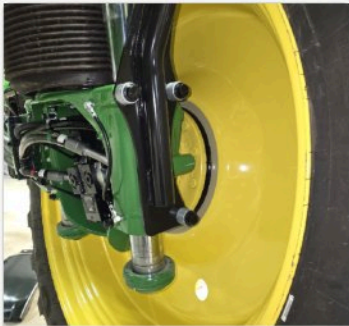
**WHEEL AND HYDRODRIVE AREA**

**CERAKOTE MC-2200 ON DOCUMENTED WHEEL AND HYDRODRIVE SURFACES**

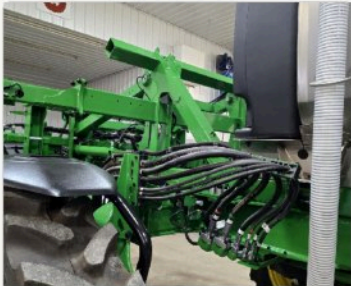
BOOM STRUCTURE AND PLUMBING

CERAKOTE MC-2200 ON DOCUMENTED BOOM AND SPRAY-SYSTEM SURFACES

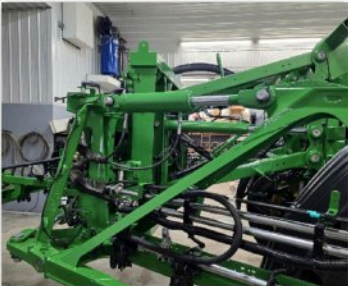
BOOM STRUCTURE AND NOZZLE LINES

CERAKOTE MC-2200 ON DOCUMENTED BOOM, NOZZLES, AND SUPPORT BRACKETS

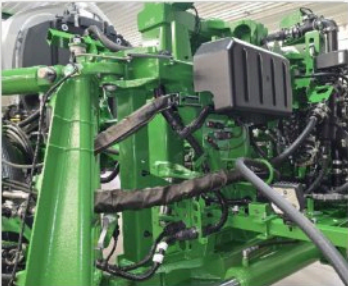
REAR RACK AND LIFT ASSEMBLY

CERAKOTE MC-2200 ON DOCUMENTED REAR RACK AND LIFTING MECHANISM

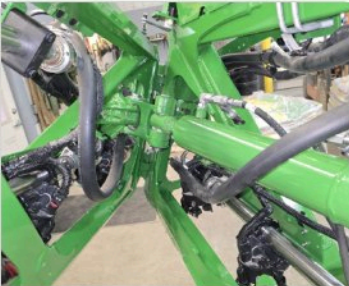
BOOM FRAME CROSSMEMBER AND CONNECTED PLUMBING

CERAKOTE MC-2200 ON DOCUMENTED BOOM AND SUPPORT SURFACES

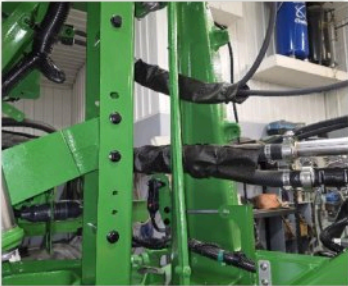
ACCESS STRUCTURE HINGE AND BRACKETRY

CERAKOTE MC-2200 ON DOCUMENTED ACCESS AND FRAME SURFACES

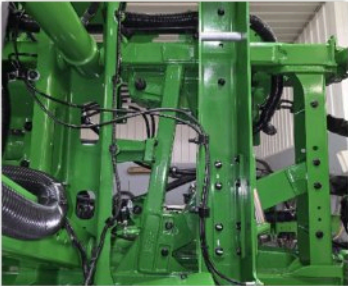
REAR RACK AND FRAME SUPPORT DETAIL

CERAKOTE MC-2200 ON DOCUMENTED REAR RACK AND FRAME SURFACES

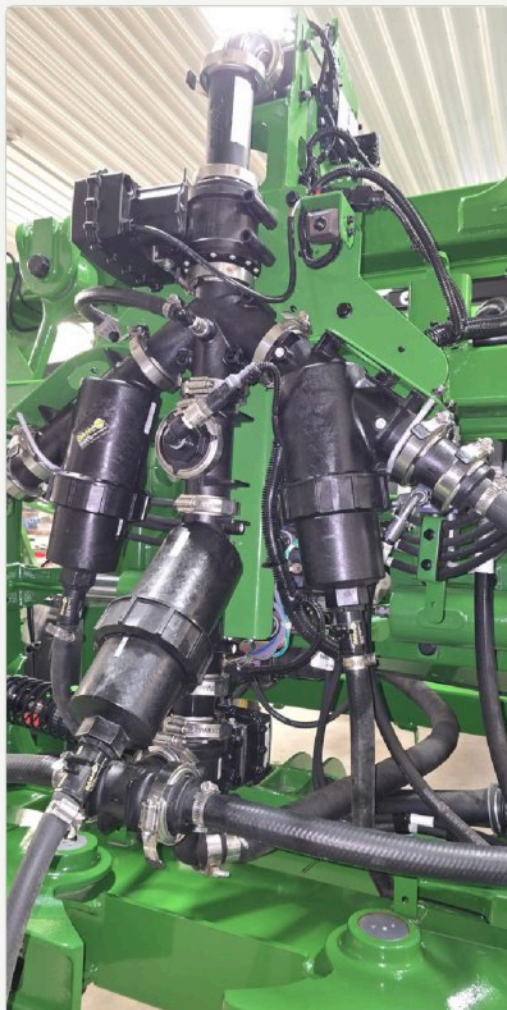
**CHEMICAL PLUMBING MANIFOLD****CERAKOTE MC-2200 ON DOCUMENTED FITTINGS, COUPLERS, AND MANIFOLD AREAS**

Fittings, couplers, clamps, and hose routing document complex chemical-exposure geometry.

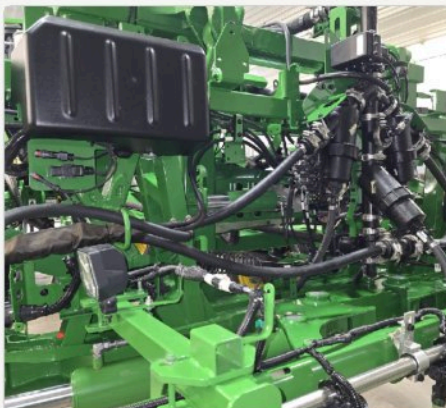
**NOZZLE BANK AND REAR RACK****CERAKOTE MC-2200 ON DOCUMENTED SPRAY-SYSTEM FITTINGS AND SUPPORT STRUCTURES**

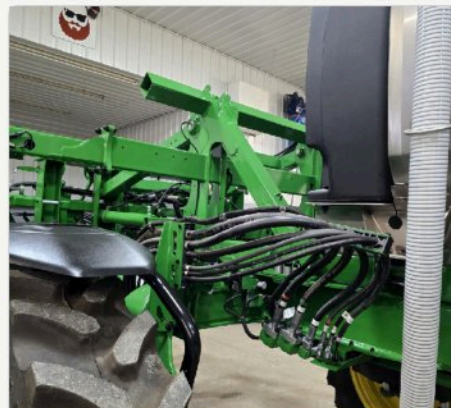
**BOOM PLUMBING SIDE VIEW****CERAKOTE MC-2200 ON DOCUMENTED BOOM AND SPRAY-SYSTEM SURFACES**

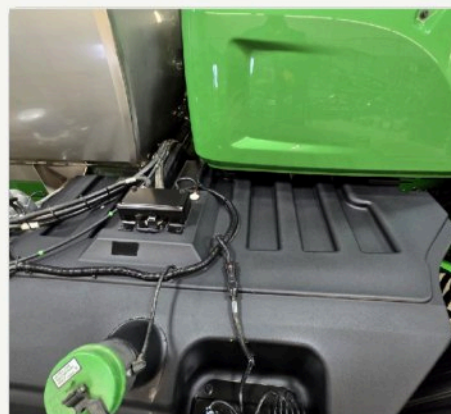
**BLACK PLASTIC TANK SURFACE****ROAR LEGACY ON DOCUMENTED BLACK PLASTIC SURFACES**

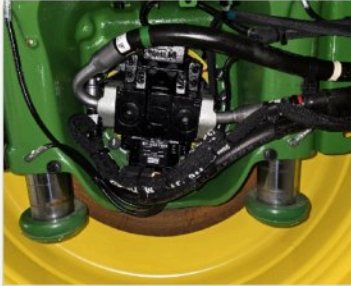
## HYDRODRIVE AND INSIDE WHEEL SERVICE AREA

### CERAKOTE MC-2200 ON DOCUMENTED WORKING SURFACES

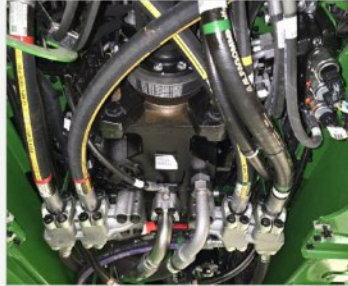
## UNDERBELLY HYDRAULIC SERVICE AREA

### CERAKOTE MC-2200 ON DOCUMENTED UNDERCHASSIS AND FITTINGS

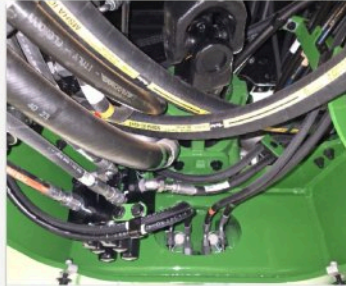
## UNDERCHASSIS PLUMBING AND FITTINGS

### CERAKOTE MC-2200 ON DOCUMENTED UNDERCHASSIS COMPONENTS

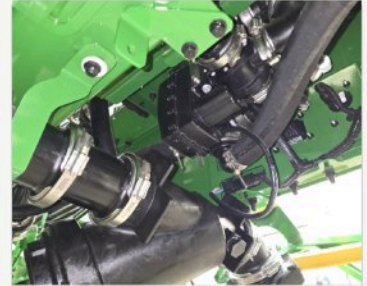
## UNDERBODY FITTINGS AND FRAME-CONNECTED COMPONENTS

### CERAKOTE MC-2200 ON DOCUMENTED FITTINGS AND CONNECTED SURFACES

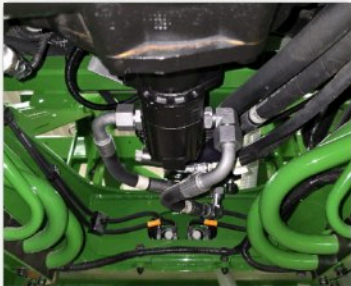
## UNDERCHASSIS AND BELLY ACCESS DOORS

### CERAKOTE MC-2200 ON DOCUMENTED UNDERCHASSIS AND ACCESS SURFACES

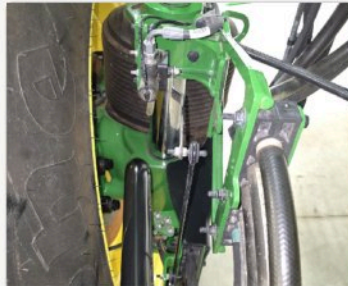
## WHEEL AND HYDRODRIVE CLOSE REFERENCE

### CERAKOTE MC-2200 ON DOCUMENTED HYDRODRIVE AND WHEEL-ZONE SURFACES

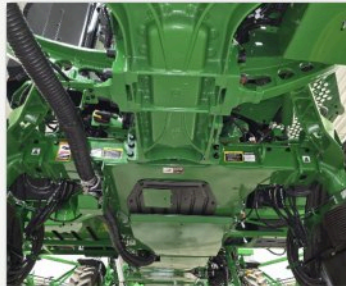
## FORWARD UNDERCARRIAGE AND BELLY ACCESS BASELINE

### CERAKOTE MC-2200 ON DOCUMENTED UNDERCHASSIS AND ACCESS SURFACES

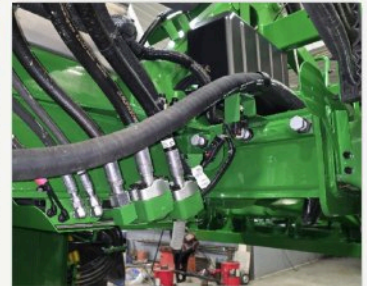
## SIDE FRAME HYDRAULIC LINES

### CERAKOTE MC-2200 ON DOCUMENTED FRAME-CONNECTED SURFACES

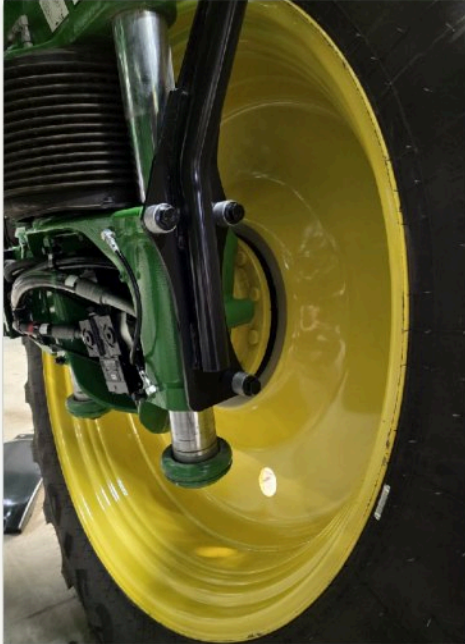
**WHEEL-FACE FINISH REFERENCE****CERAKOTE MC-2200 ON DOCUMENTED WHEEL SURFACES**

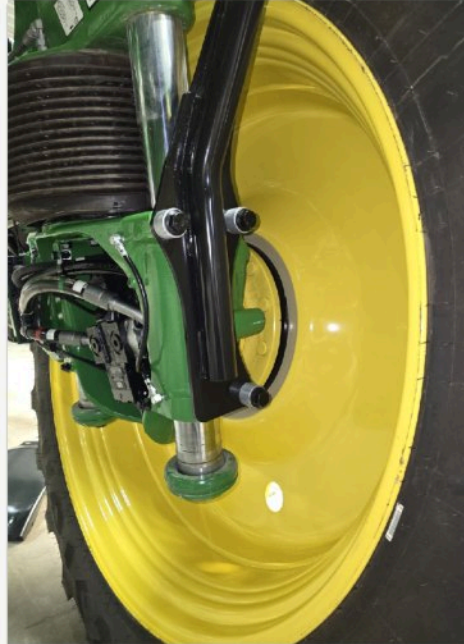
**WHEEL AND HYDRODRIVE DETAIL****CERAKOTE MC-2200 ON DOCUMENTED WHEEL AND HYDRODRIVE SURFACES**

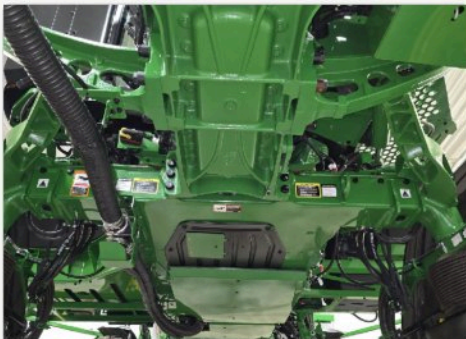
FORWARD UNDERCARRIAGE

CERAKOTE MC-2200 ON DOCUMENTED UNDERCHASSIS AND ACCESS SURFACES

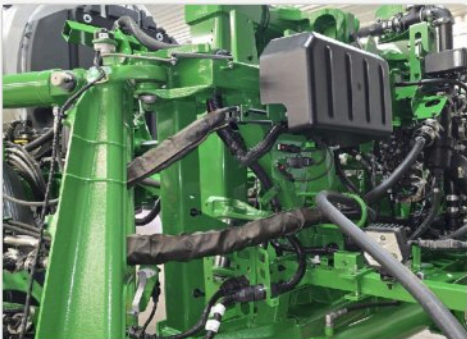
REAR RACK AND LIFT

CERAKOTE MC-2200 ON DOCUMENTED REAR RACK AND LIFTING MECHANISM

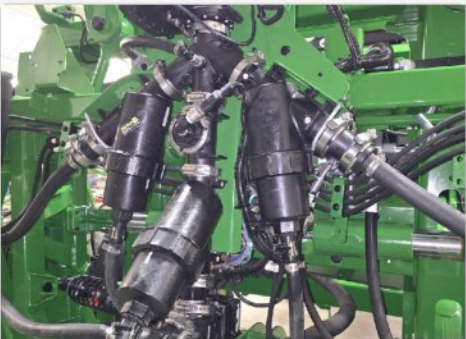
FITTINGS AND MANIFOLD

CERAKOTE MC-2200 ON DOCUMENTED FITTINGS, COUPLERS, AND MANIFOLD AREAS
