# John Deere 410R Sprayer Preservation Dossier

Documented preservation and coating installation record for a John Deere 410R self-propelled sprayer, with condition notes, surface preparation, component coverage, chemical exposure areas, coating placement, and future inspection reference points.

John Deere 410R self-propelled sprayer

Preservation and coating installation dossier

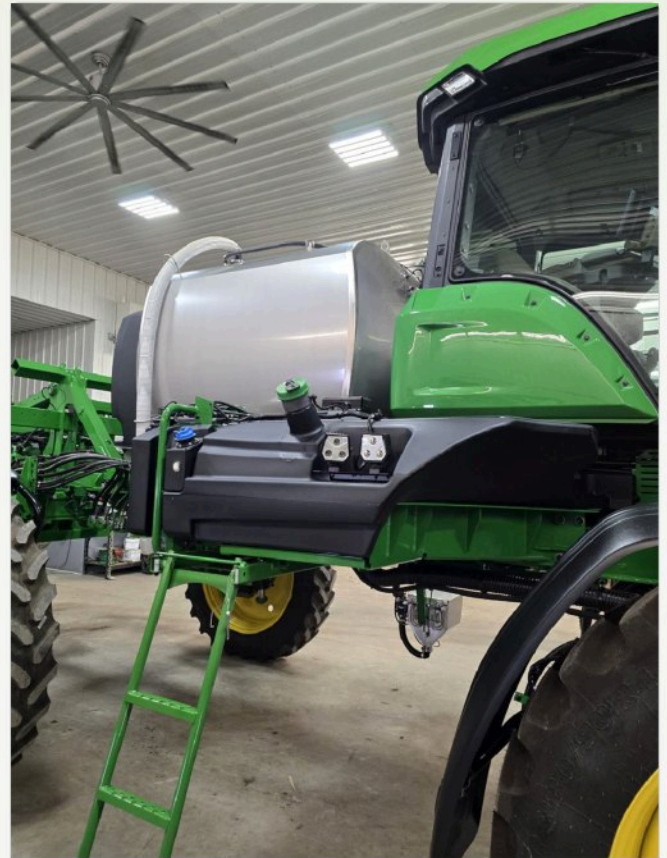
Completed side view with tank, platform, access structure, and body-side coverage.

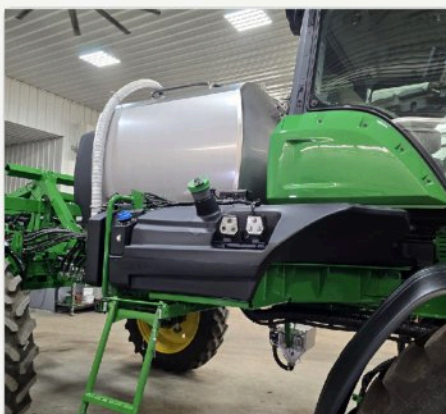
**TANK AND PLATFORM AREA****COMPLETED SERVICE EVIDENCE**

Document tank, platform, ladder, fender, and body-side coverage.

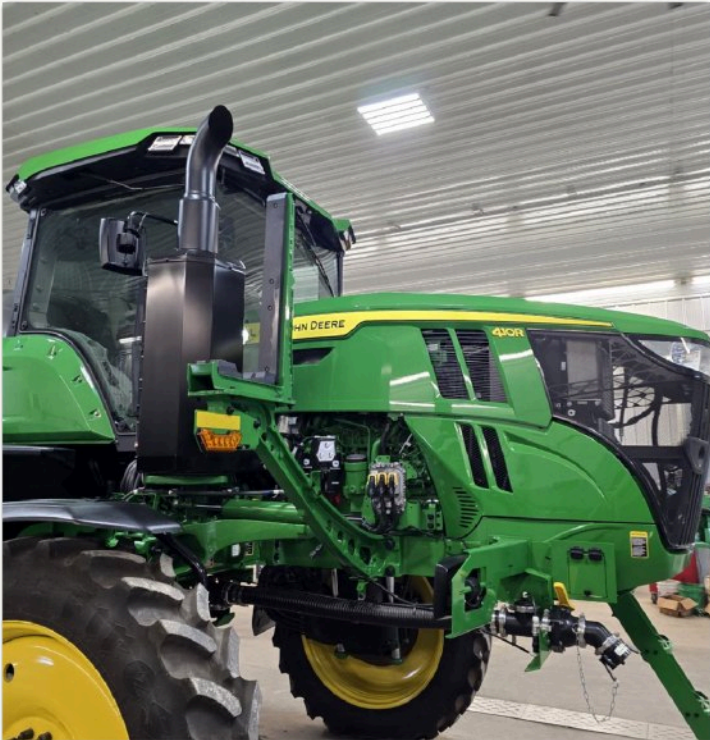
COMPLETED SERVICE CONTEXT  
COMPLETED SERVICE EVIDENCE

Completed side view showing tank, cab, body, wheel, access, and service areas after the preservation work.
